SPECIAL AIRWORTHINESS INFORMATION BULLETIN

No. SW-03-44
June 20, 2003

Potential Unsafe Condition Agusta A109 Helicopters Tail Rotor Trunnion P/N 109-0131-05

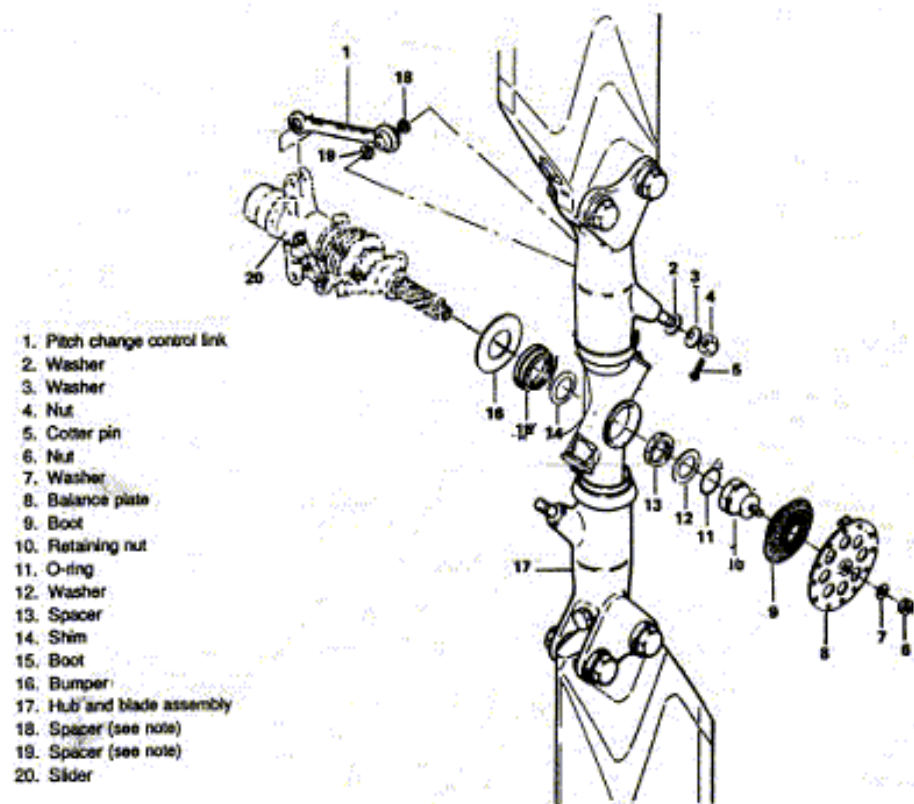
Figure 1.

Although the exact cause of the mark is unknown we suspect it is a tool mark that was made during reassembly of the T/R hub after an inspection. During the installation and removal process of the T/R hub a washer (Fig 1 item 12) is bent to provide a locking feature to the spacer (Fig 1 item 13) and the retaining nut (Fig 1 item 10). The maintenance manual does not specify the method or tool for bending the washer, nor does it specify limits for scratches, dents, or other damage. However, the Component Maintenance Manual (Fig 2.) does specify a damage limit of 0.1 mm (0.004 inches) in Area 1.

During disassembly and reassembly of the T/R hub, use extreme caution to not scratch, dent or otherwise damage the T/R trunnion. A one-time inspection should be accomplished to ensure the trunnion has not been previously damaged.

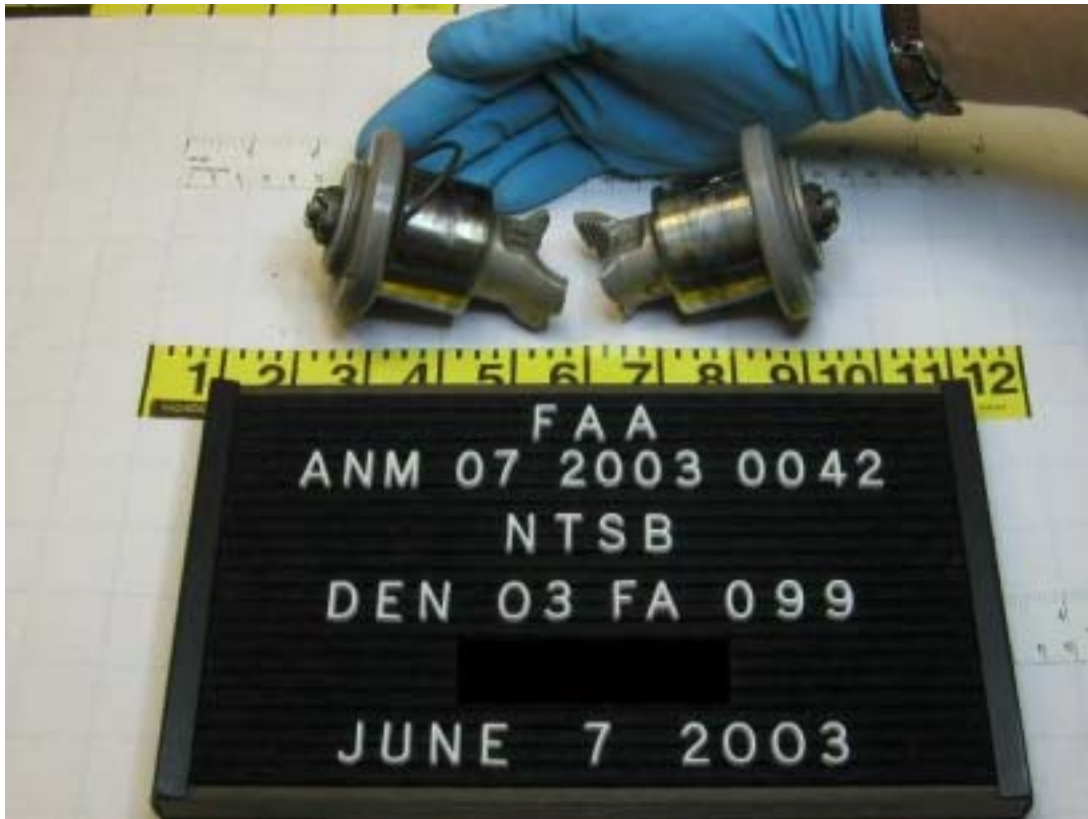
The trunnion failed through the splined portion in approximately two equal halves (See photo 1). Initial examination reveals indications of fatigue (Photo 2). A mark on the outboard surface of the trunnion was observed and appears to be a possible fatigue initiation point (Photo 3).

Photo 1 Separated Trunnion

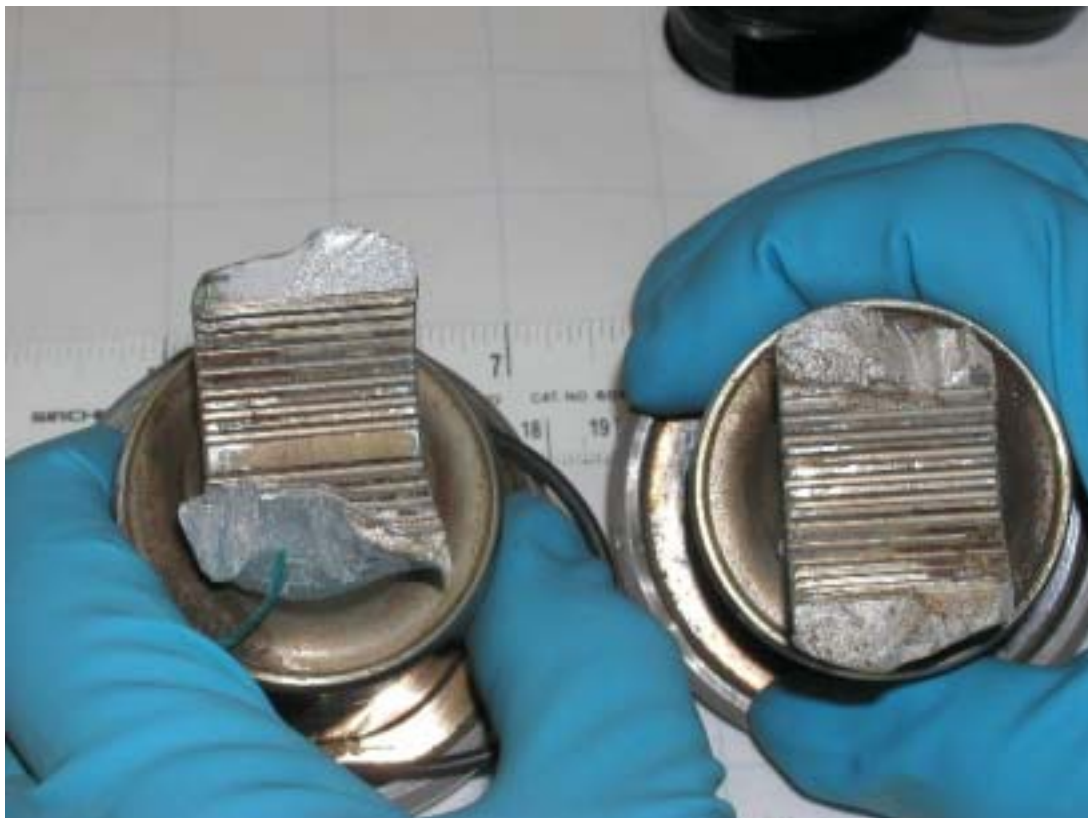
**Photo 2
Fracture Surfaces**

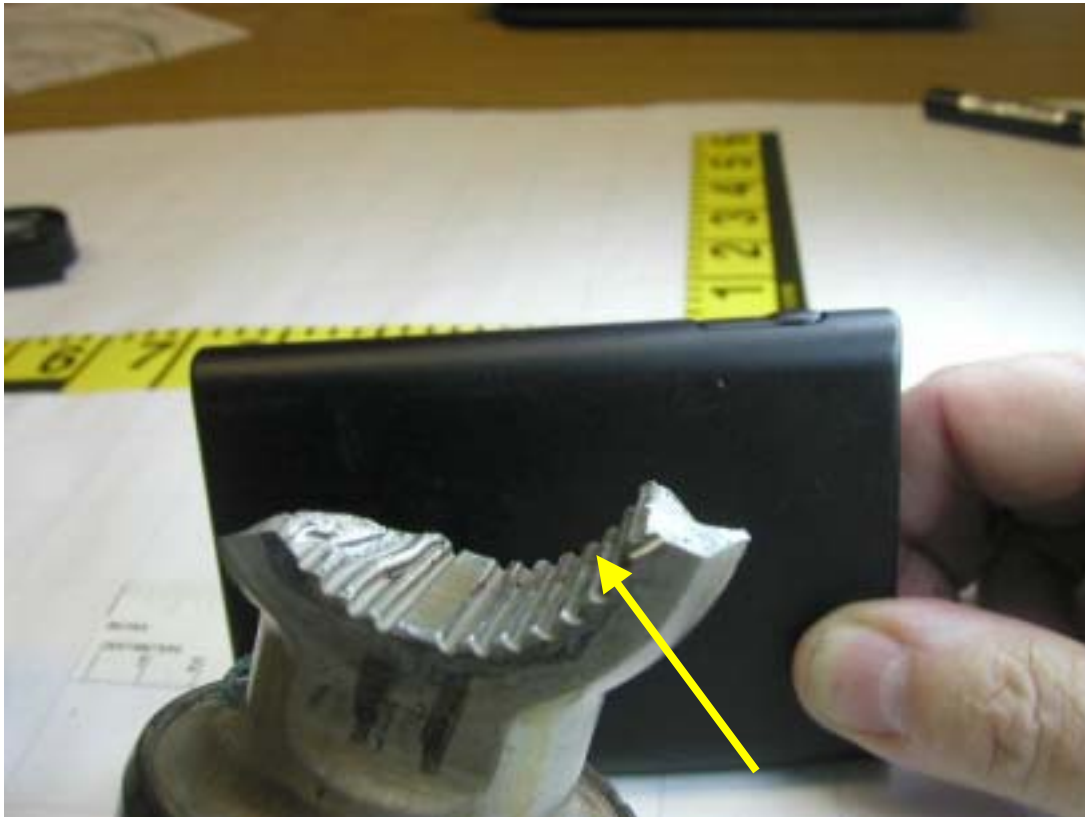
Photo 3
Unknown Mark on Surface
